# Pavement Edge Treatment

WA-RD 798.1

**Post-Construction Report**  
Experimental Feature WA 11-01

Contract 8017, SR 395  
Lee Road to Junction I-90

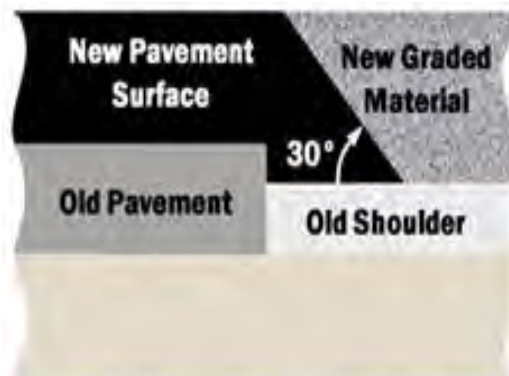
Figure 2. Safety Edge<sub>SM</sub> detail. (FHWA Safety Edge PowerPoint)

The Safety Edge<sub>SM</sub> pavement edge treatment provides a non-vertical wedge at the edge of the pavement which reduces the steering forces needed for re-entering the roadway. With this treatment, the pavement edge is sloped at a 30° angle (see Figure 2). The presence of a slope instead of a vertical face makes it easier for a vehicle to re-enter the roadway after inadvertently driving off the edge of the pavement. Figures 3 and 4 are diagrams of a pavement edge without and with the pavement edge treatment. Figures 5 and 6 are photos of a pavement with a vertical edge and one with the pavement edge treatment. Figure 7 shows a pavement under construction with no edge treatment and with edge treatment.

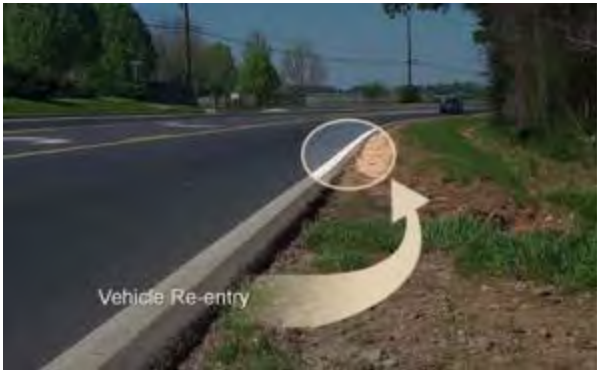
Figure 5. Vertical drop off at pavement edge. (FHWA Safety Edge<sub>SM</sub> PowerPoint)

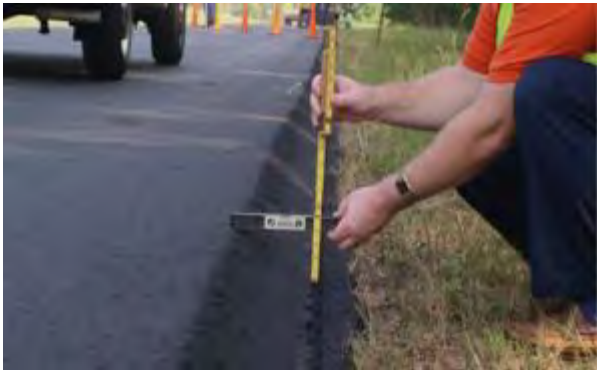
Figure 6. Sloping edge produced by pavement edge hardware. (FHWA Safety Edge<sub>SM</sub> PowerPoint)

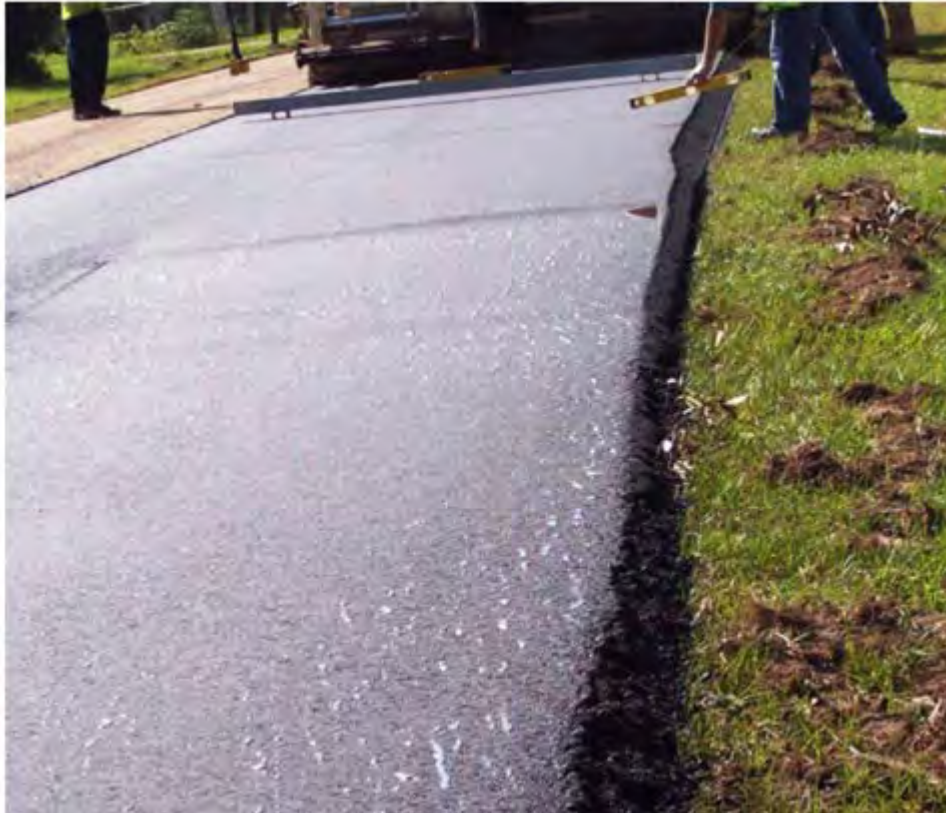
Figure 7. Pavement edge without the Safety Edge<sub>SM</sub> in foreground and with the Safety Edge<sub>SM</sub> in the background. (FHWA Safety Edge PowerPoint)

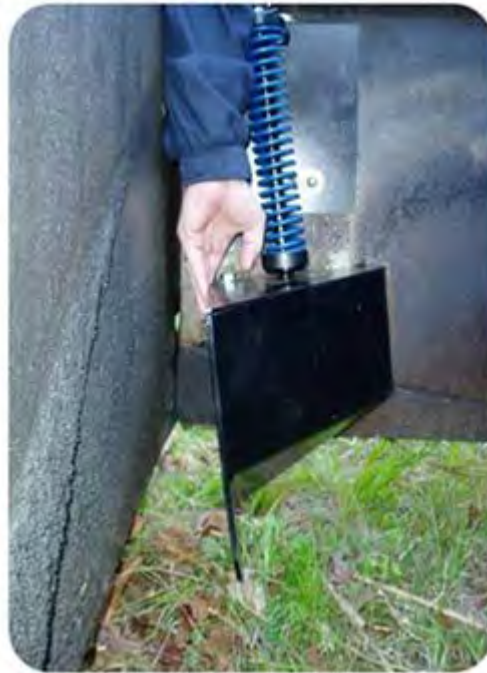
Figure 9. Troxler SafeTSlope™ Edge Smoother.

trowel to smooth the surface of the wedge fillet. Both left and right-hand devices are available for paving with or against traffic.

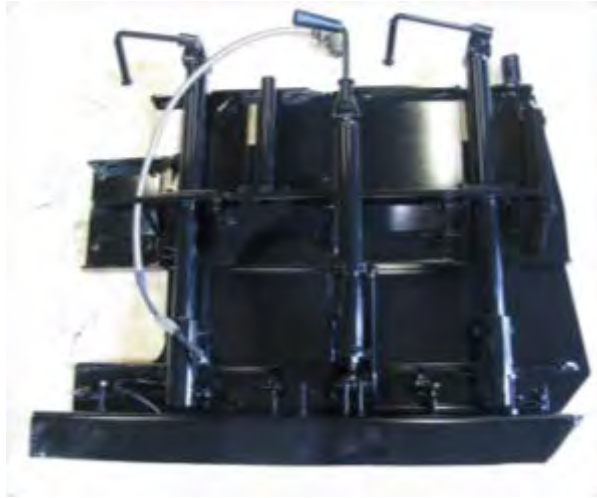
Figure 10. Carlson Safety Edge End Gate hardware. (FHWA, Madison Co., WI)

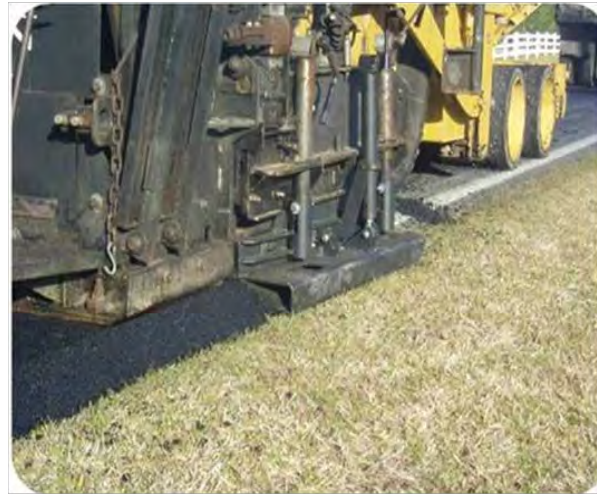
Figure 11. Carlson Safety Edge End Gate in use. (FHWA, Menominee, WI)

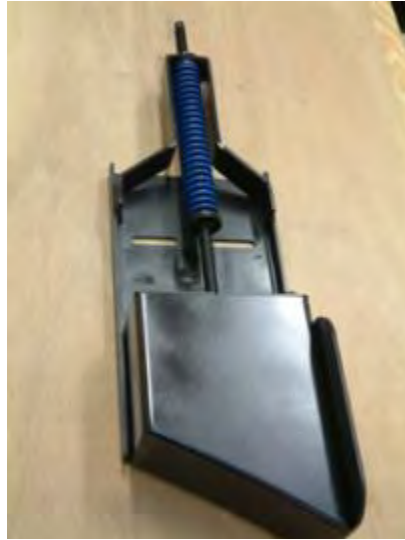
Figure 12. The Advant-Edge™ creates a tapered 30° safety edge along the shoulder of the road.

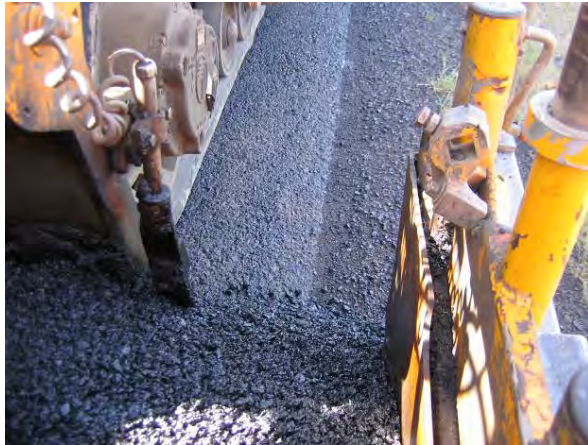
Figure 20. Close-up of sloped pavement edge showing top of slope at existing pavement edge.

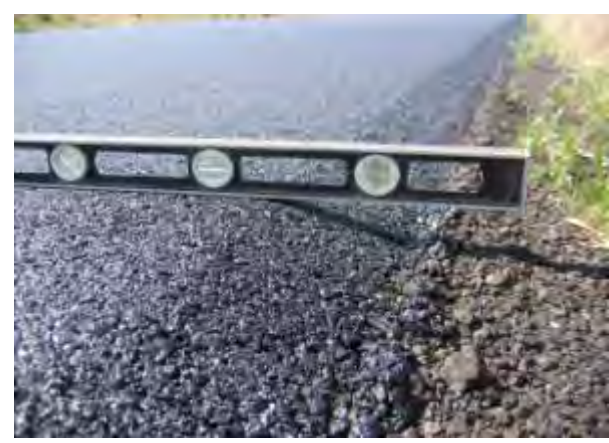
Figure 23. Angle of sloped pavement edge. Note the uniform compaction.

Measurements were taken of the pavement edge angle at various locations before and after compaction of the edge. The results are summarized in Table 2. The average final slope angle of the compacted slopes at 23° misses the 30° goal on the good side since it is a much flatter slope and would be easier to mount by a vehicle running off the road. The FHWA Design and Construction Guide states that the recommended range for the slopes is 26 to 40 degrees ([FHWA Safety Edge Web Site](#)).

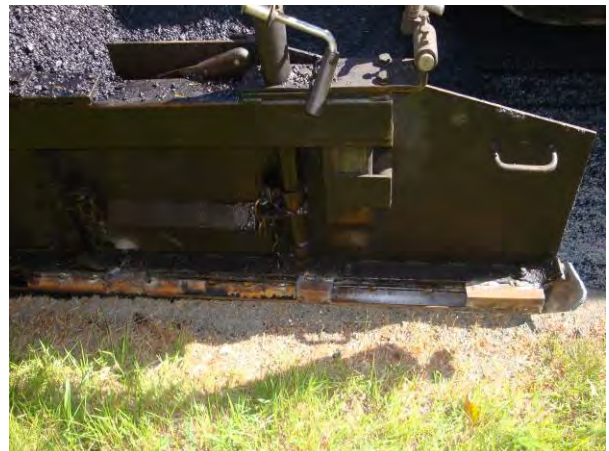
Figure 28. Side view of TransTech hardware.

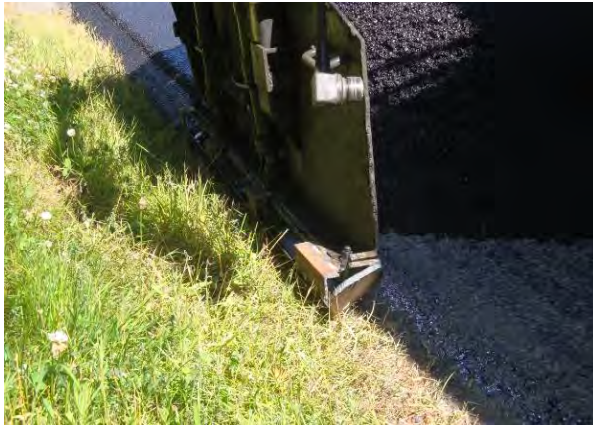
Figure 29. End view of TransTech pavement hardware without the roller.

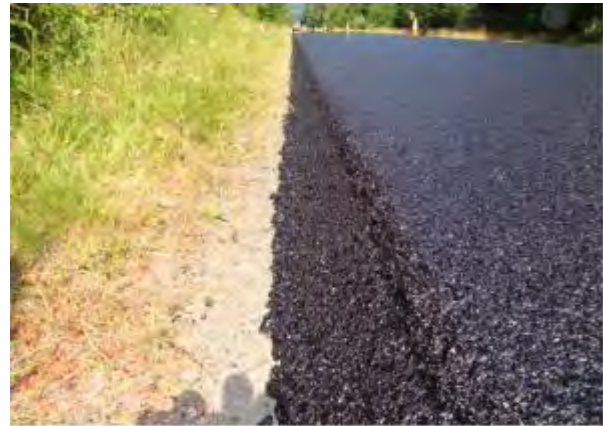
Figure 30. Pavement edge formed by the TransTech hardware prior to adding the roller. Note open texture of the HMA.

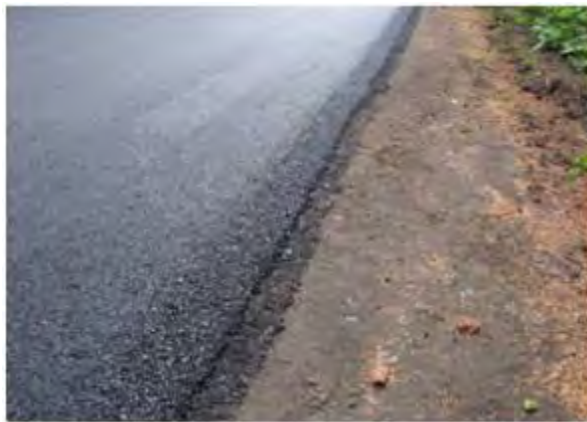
Figure 31. Pavement edge treatment after addition of a roller behind the paver.

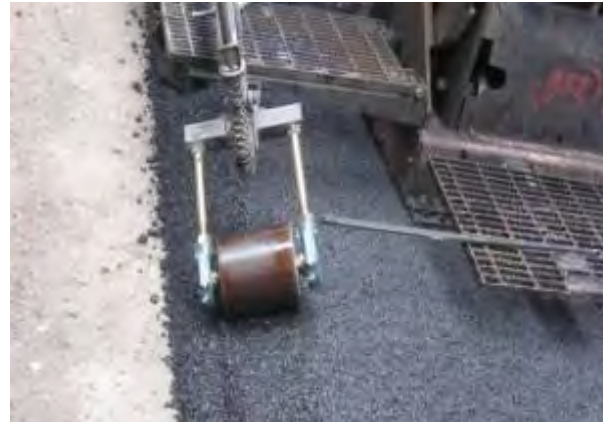
Figure 32. Roller added to compact the vertical edge at the top of the slope.

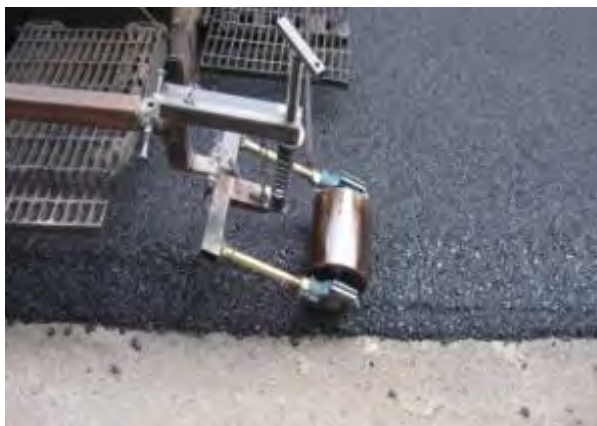
Figure 33. Roller added to compact the vertical edge at the top of the slope.

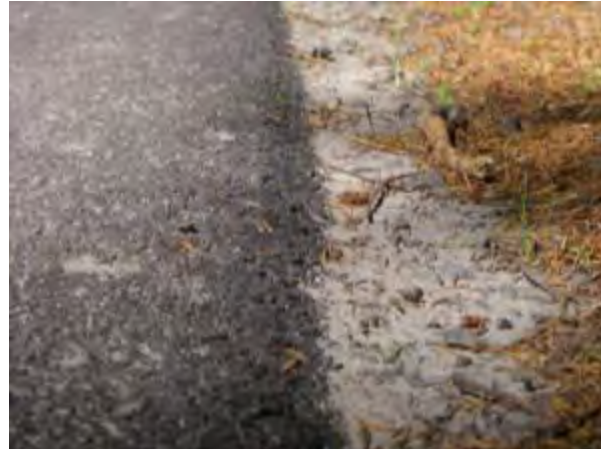
Figure 40. Close-up of pavement edge treatment on SR 410 one year after construction. Shows some exposure of pavement edge treatment.

Figures 37 through 40 show the SR 410 pavement edge treatment one year after construction. Some erosion can be seen of the shoulder material exposing the pavement edge treatment.

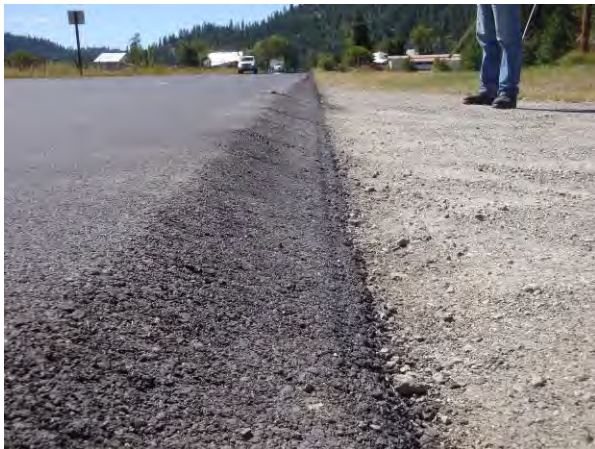
Figure 50. Slope of edge treatment across a road approach.

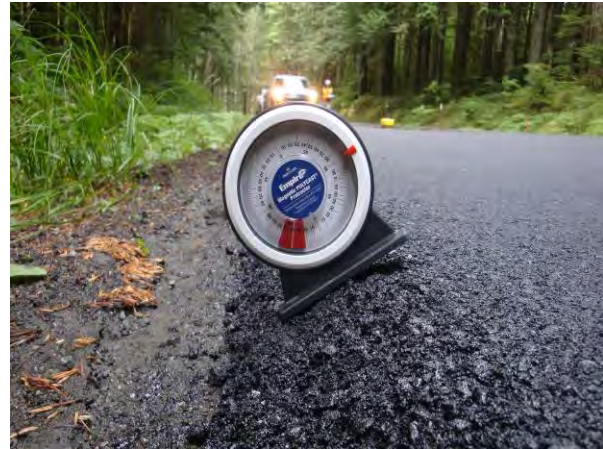
Figure 56. Slope indicator device on the edge treatment. Slope does not appear to be compacted.

Table 6 lists the slope measurement made of the finished pavement using a slope indicator gauge (Figures 56 and 57). The average of 28° meets the pavement edge goal of 30° and none of the slopes fall out of FHWA's 26 to 40° recommended range.

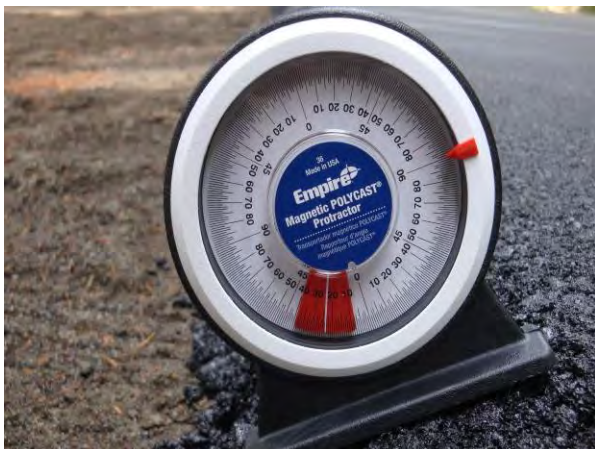
Figure 57. Close-up of slope indicator.

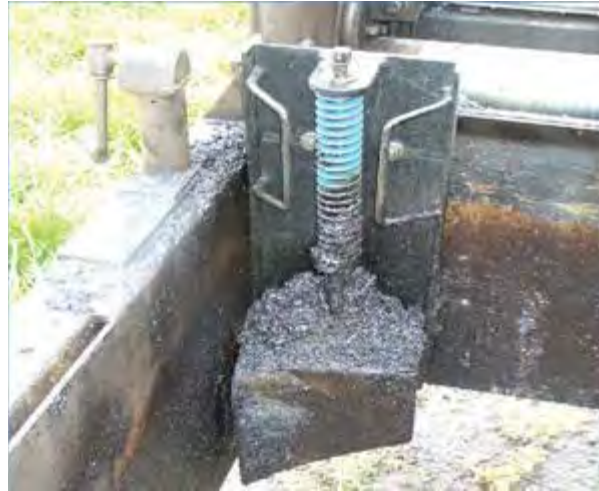
Figure 1. Pavement edge “shoe” bolted to paving machine screed (FHWA).

The pavement edge treatment is a wedge of pavement placed by a device bolted to the screed of the paving machine (Figure 1). FHWA recommends an angle of 30° to 35° between the roadway slope and the slope of the wedge (Figure 2). After completion of paving the gravel is graded back flush with the new pavement just as when a conventional vertical pavement edge is constructed.
