Maine Route 117

(5.0-inch HMA overlay, 19-mm base and 12.5-mm wearing course, Advant-Edger and TransTech Shoulder Wedge Maker)

Test Results Summary

Summary

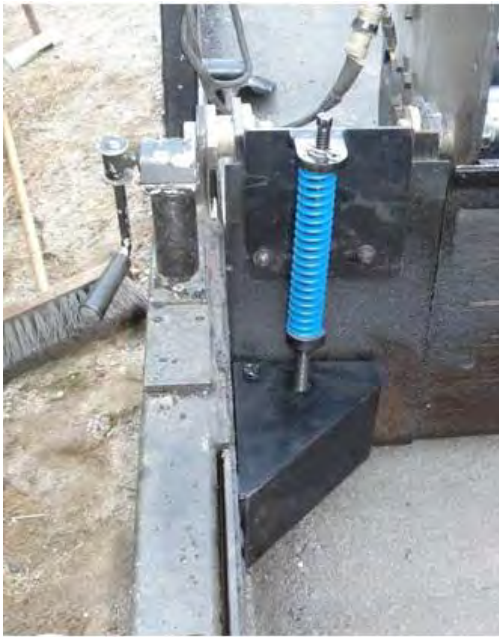
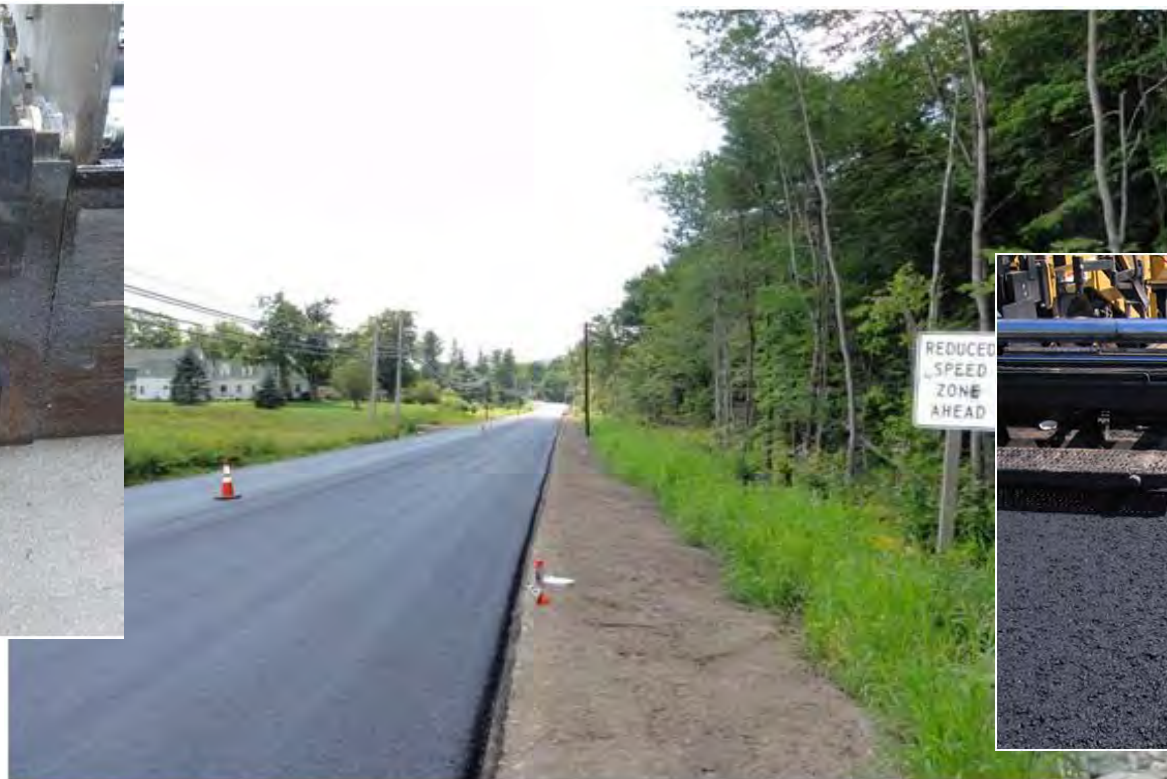
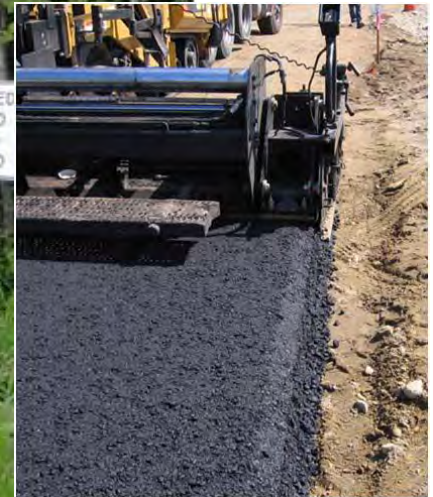
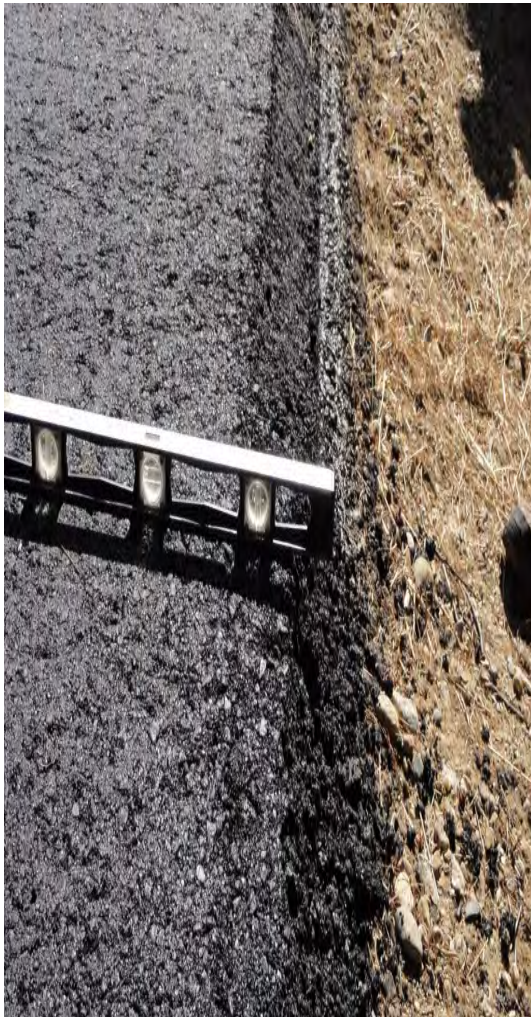
Maine Route 117

- Safety edge formed on both lifts.
- Safety edge increased pavement total width by about 8 inches.
- Safety edge and control (no safety edge) section densities were similar.
- Advant-Edger average slope was 54°.
- TransTech Shoulder Wedge Maker average slope was 45°.

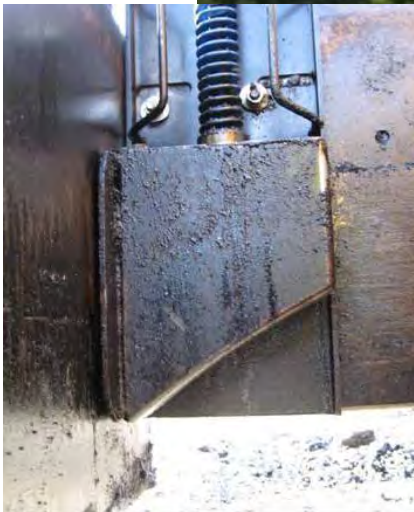
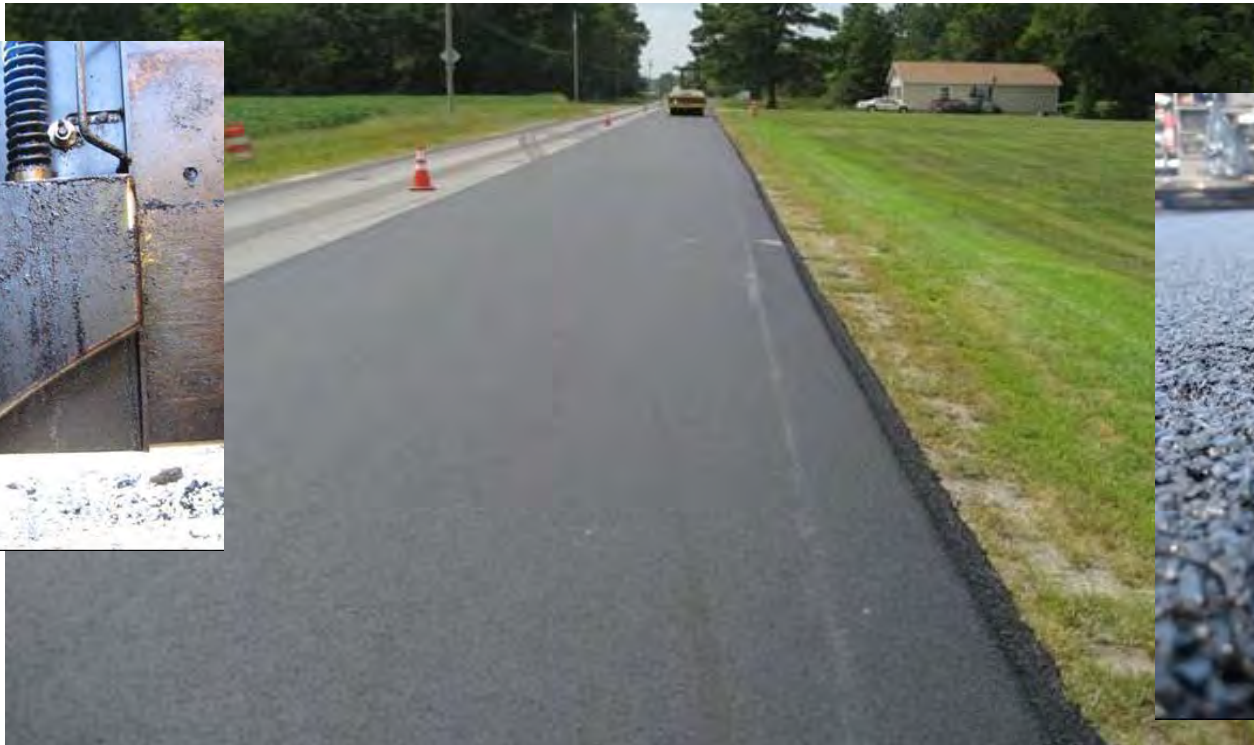
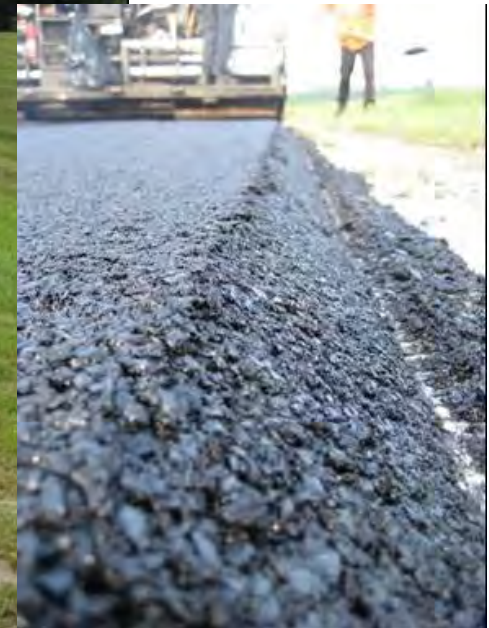
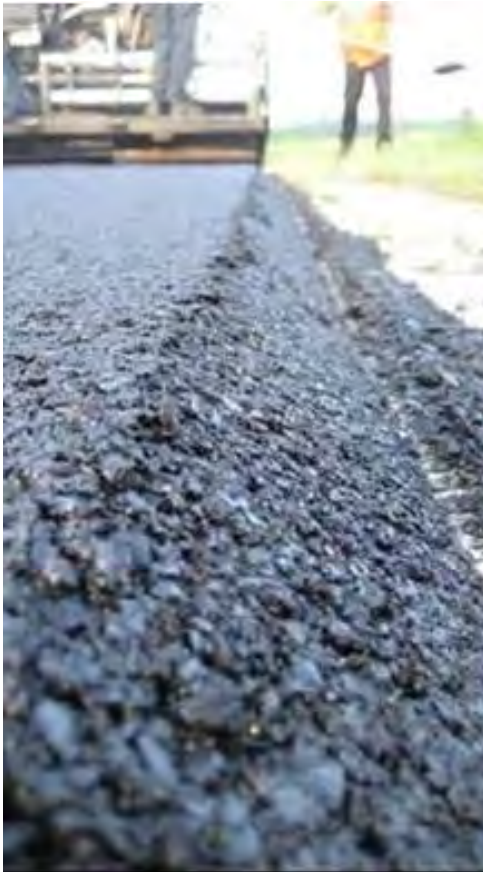
Old Furnace Road, Delaware

- Shoulders were graded to prevent edge contamination.
- Safety edge density was 2.3% higher than the control (no safety edge) section.
- TransTech Shoulder Wedge Maker average slope was 37°
- Advant-Edger average slope was 48°.
- Mix tenderness likely increased the slope made by the Advant-Edger.

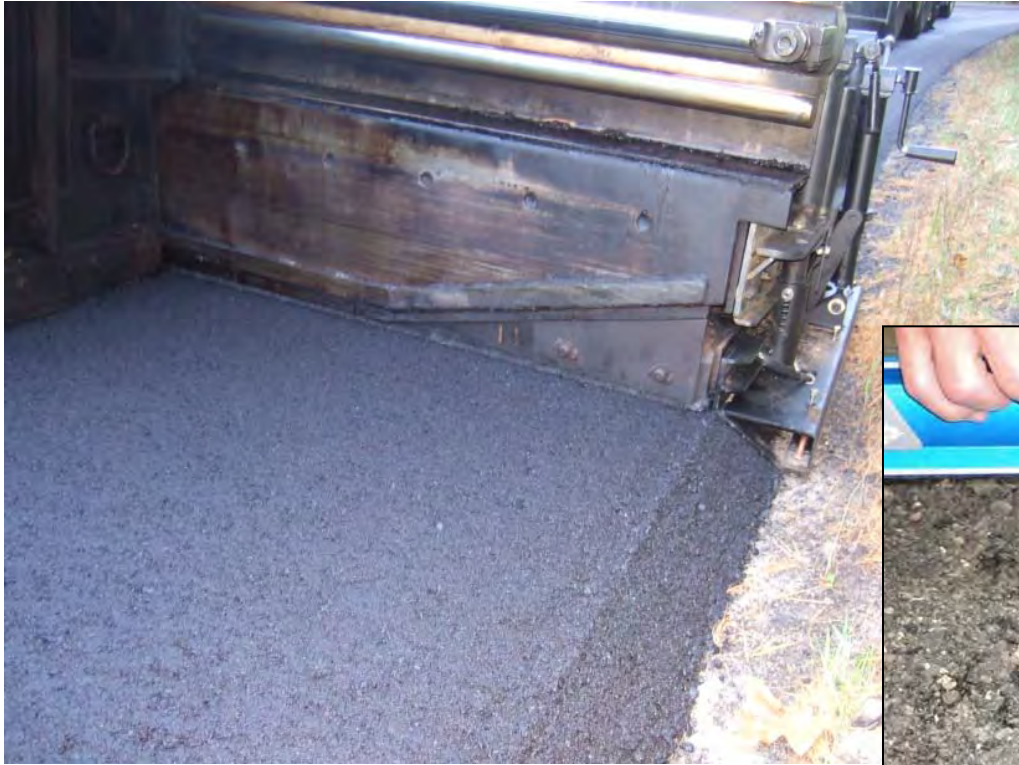
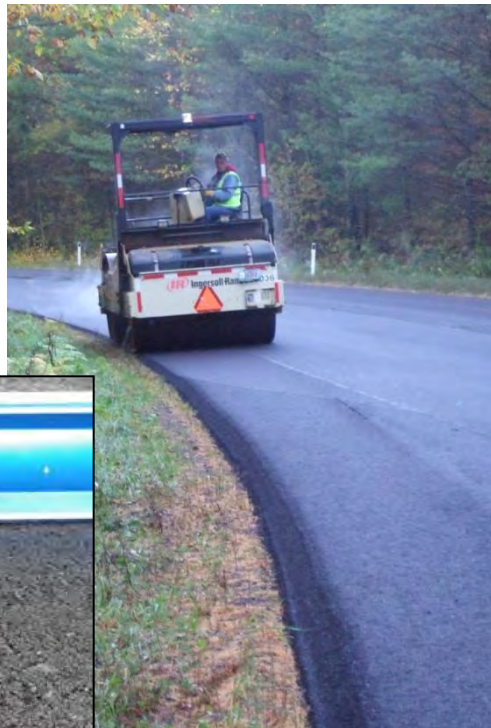
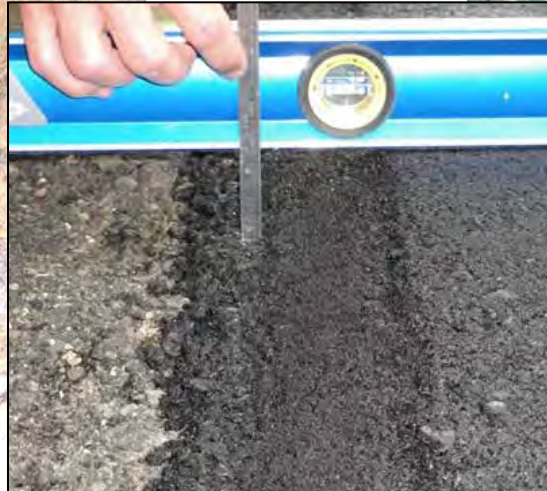
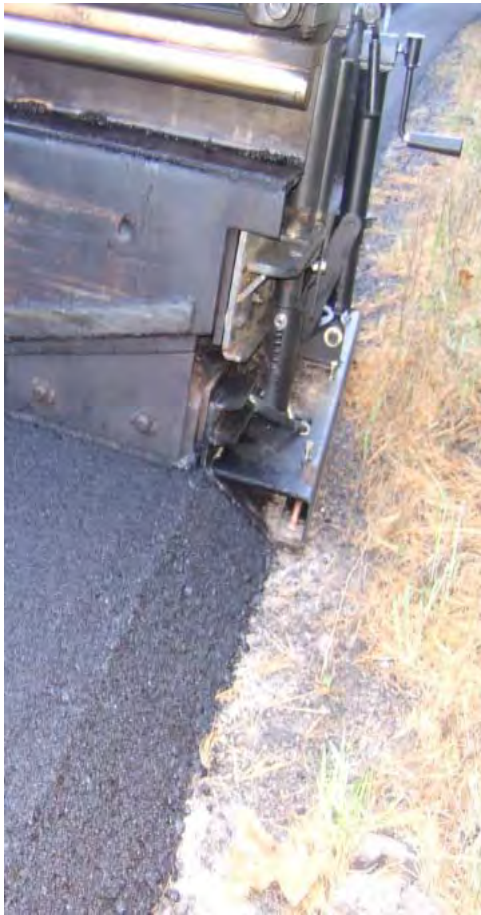
Wisconsin State Hwy 55

- Carlson devices were simple to attach and operate.
- Carlson devices produced a smooth, sealed sloped surface.
- Control section (no safety edge) edge density was 1.6% higher than the safety edge sections.
- Average slope from both devices was 35°.

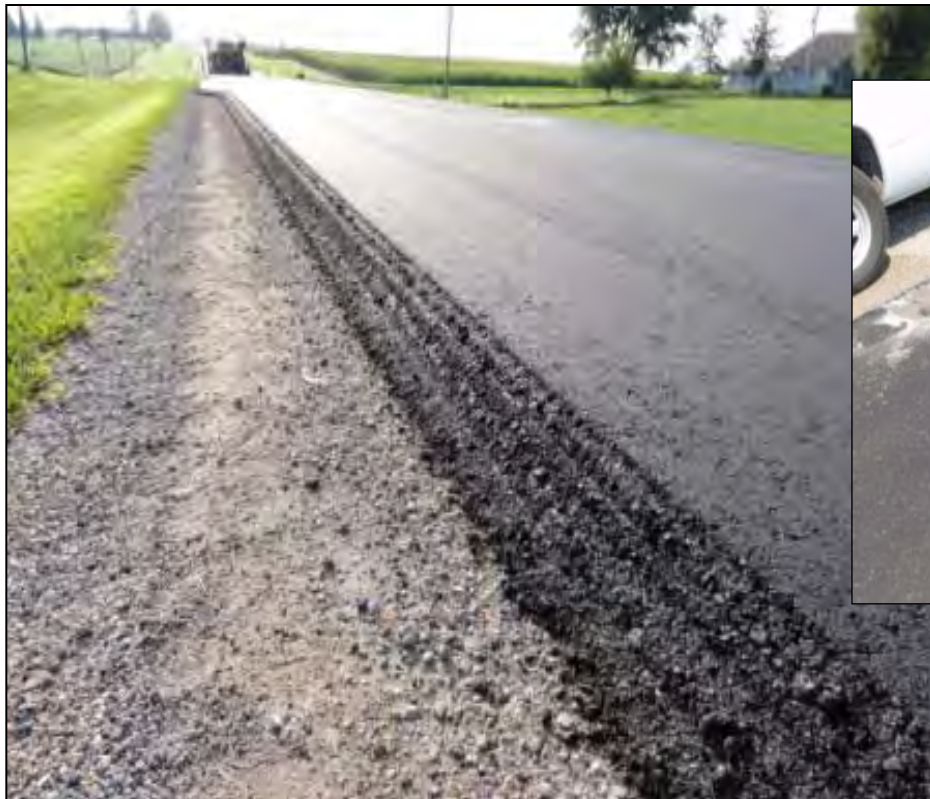
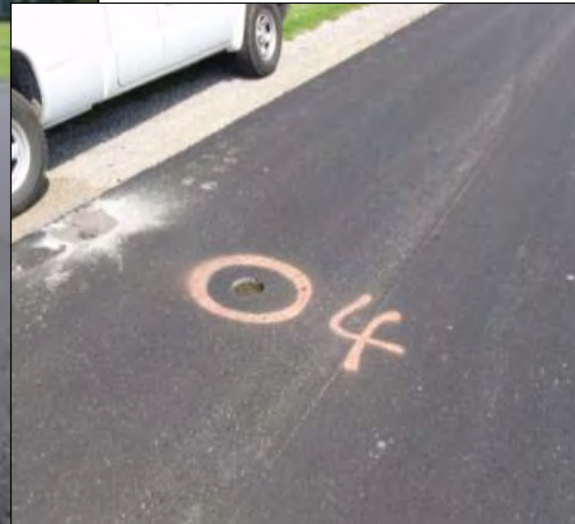
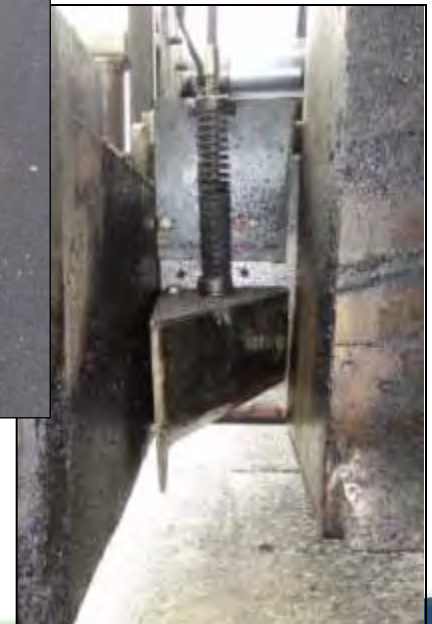
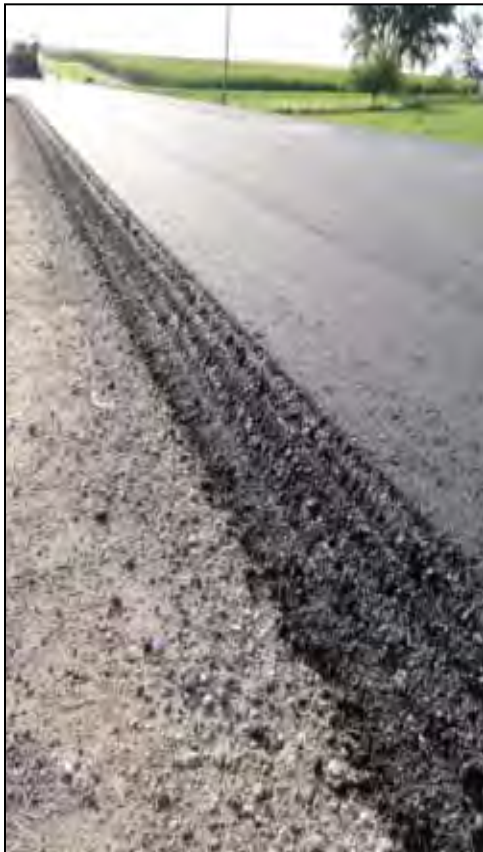
Jasper County Road F62, Iowa

- Safety edge was formed on all 3 lifts.
- Each lift was offset.
- To maintain slope - breakdown and intermediate rollers did not compact the safety edge.
- Control section (no safety edge) edge density was 5.3% higher than the safety edge sections. Control section edge was compacted by rollers.
- Average slope was 38°.

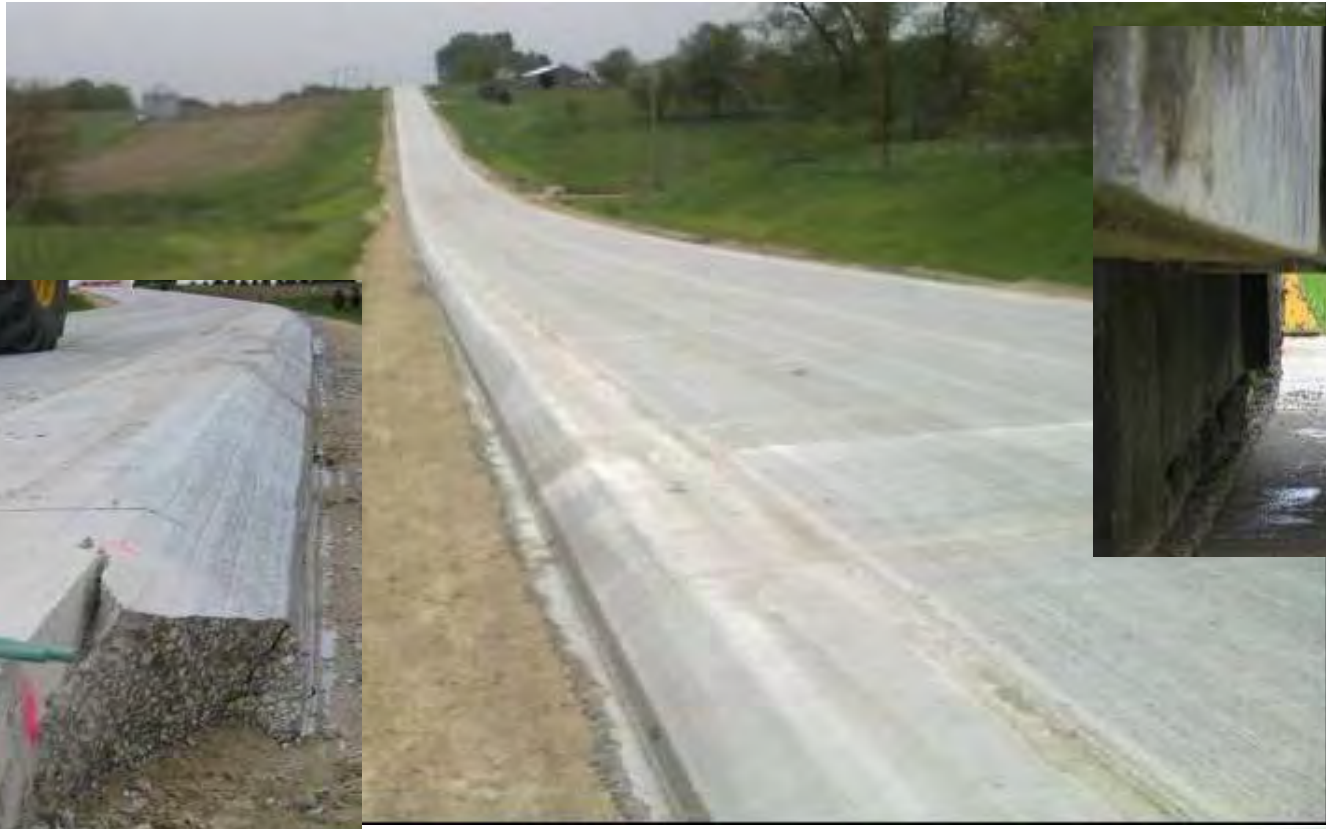
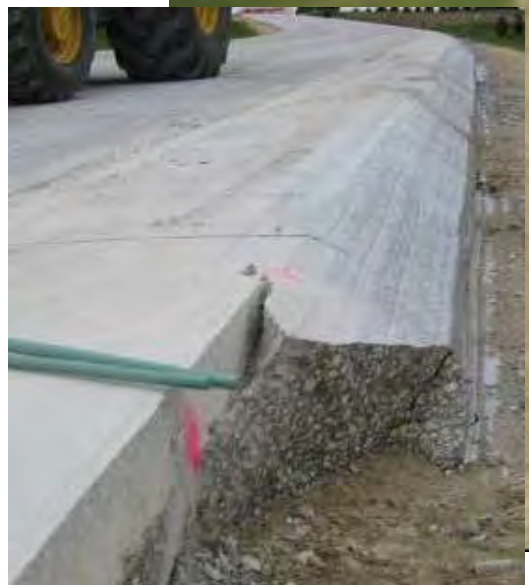
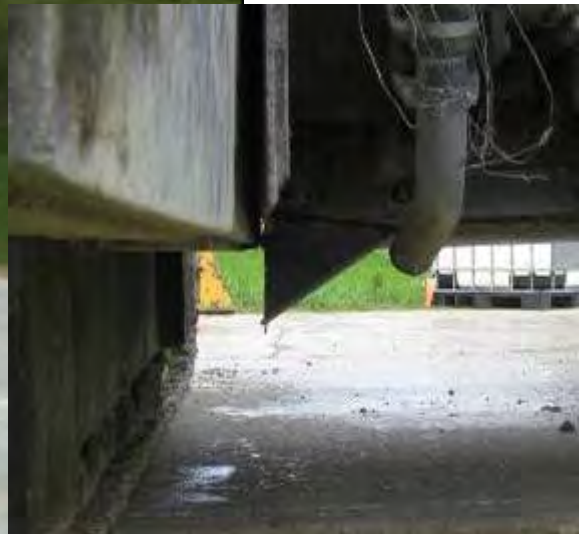
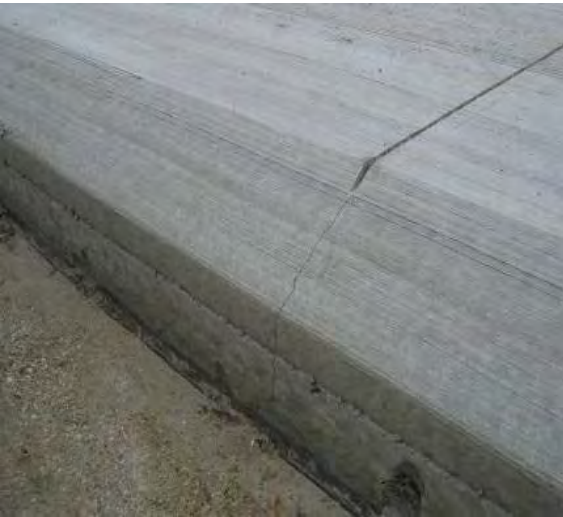
Linn/Jones County Hwy E34, Iowa

- Screed was modified to create the safety edge shape.
- Additional labor required at intersections.
- Transverse joint sawcuts stopped at the sloped face of the safety edge. Joints formed correctly through the safety edge.
- Average slope was 31.5°.
- Concrete modulus values and air voids at the edge and interior were reasonably uniform.

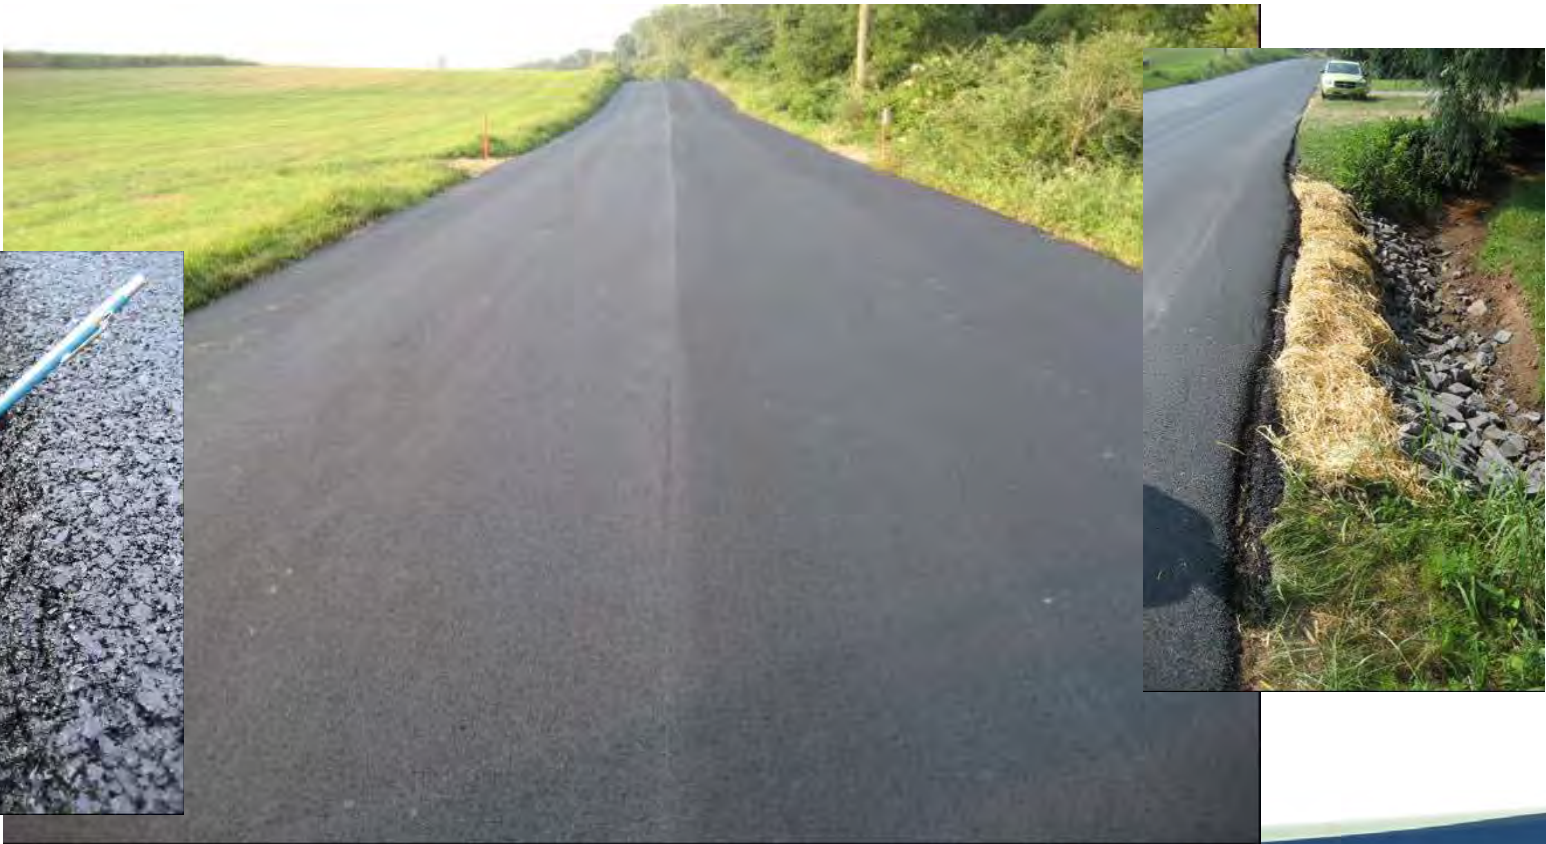
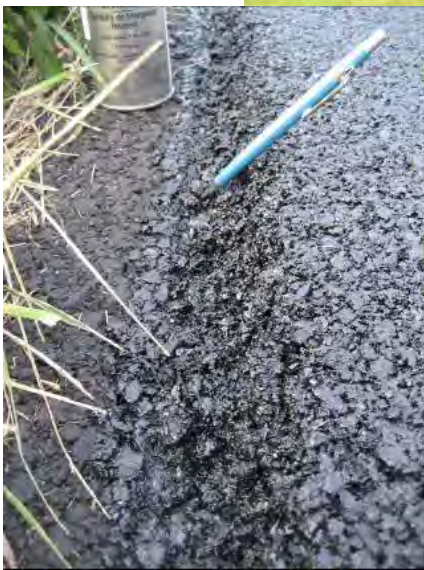
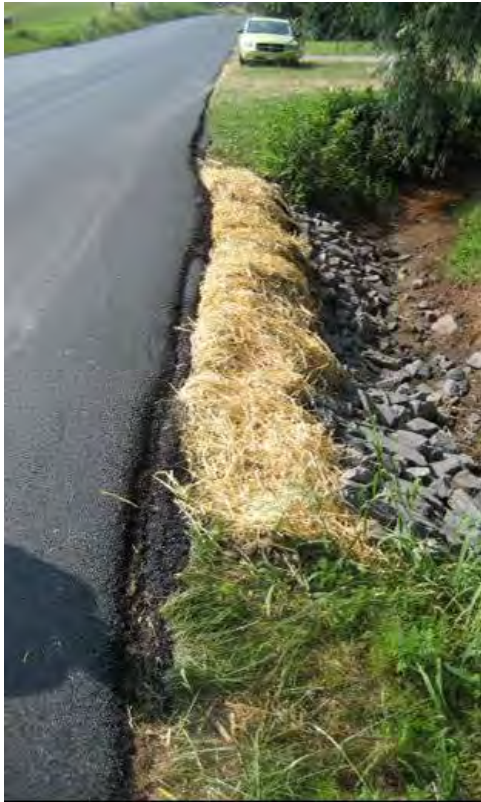
Pennsylvania State Road 2009

- Narrow roadway/shoulder conditions.
- End gate occasionally plowed up grass and soil into the safety edge.
- The sloped surface had a coarse/open texture.
- Safety edge density was 3.9% higher than the control (no safety edge) sections.
- The average slope was 48°.

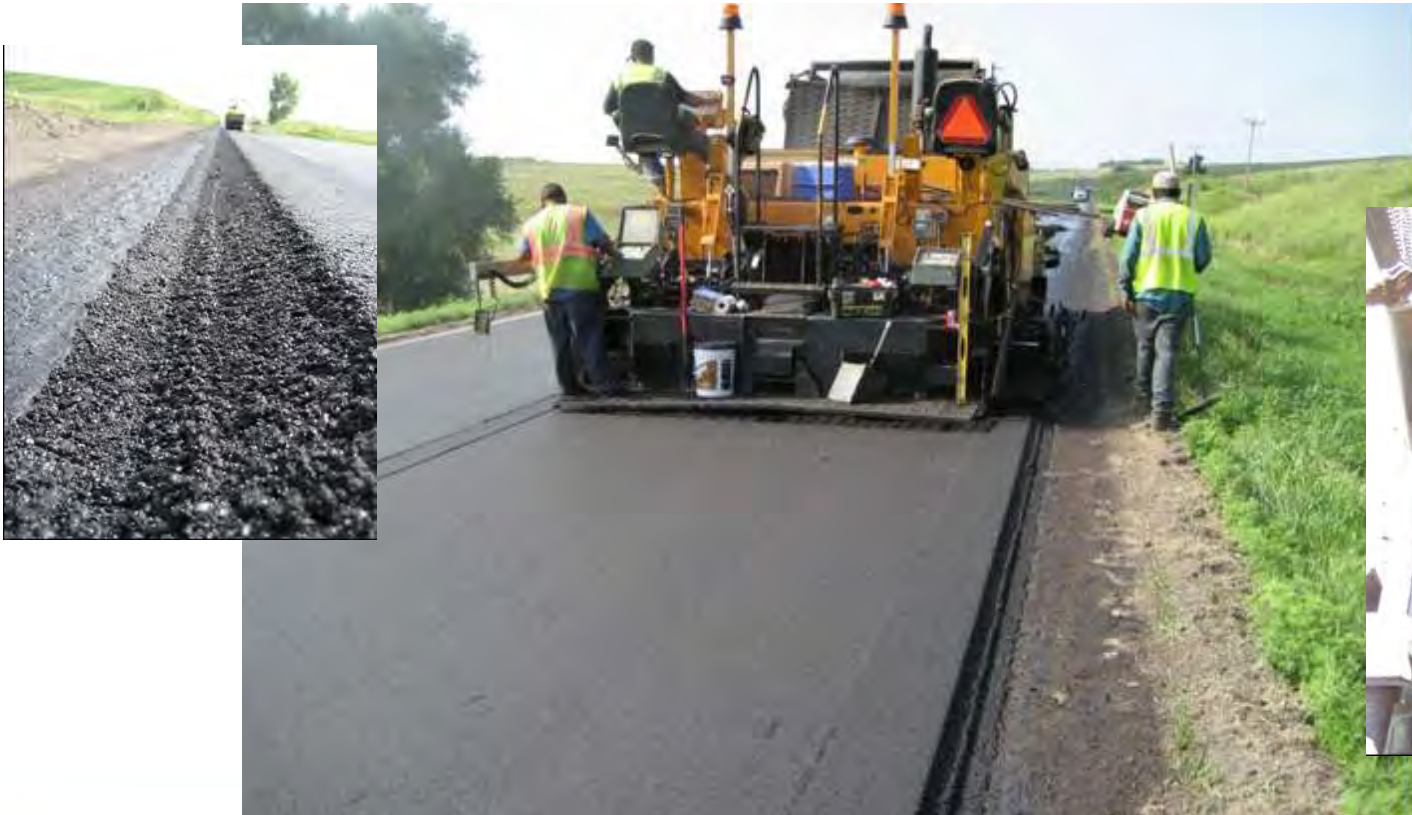
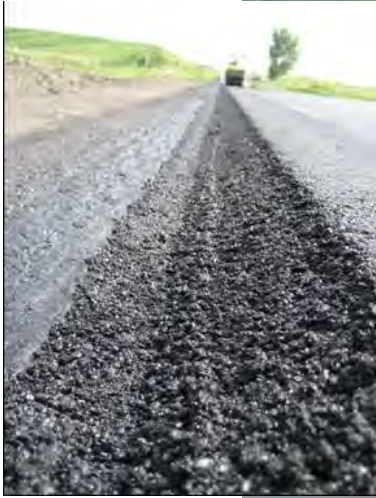
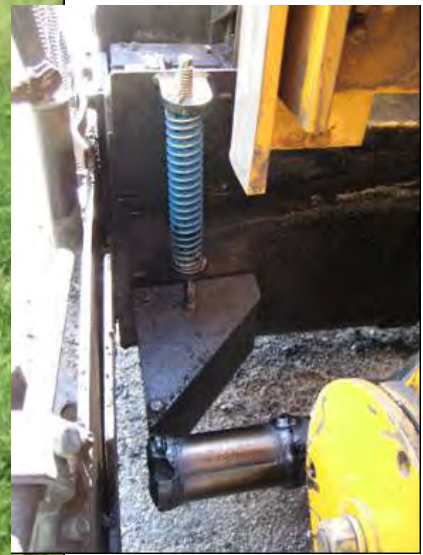
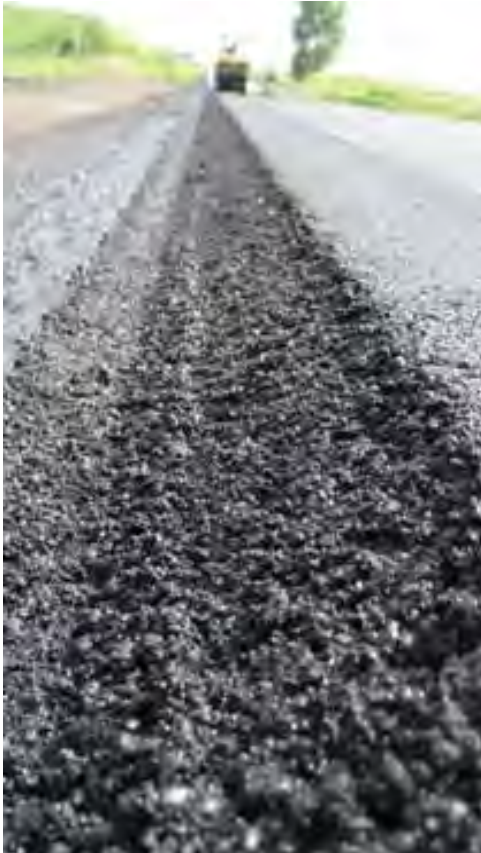
Nebraska State Route 10

- Rolling did not steepen the slope.
- Safety edge and control (no safety edge) section densities were similar.
- Average slope was 34°.

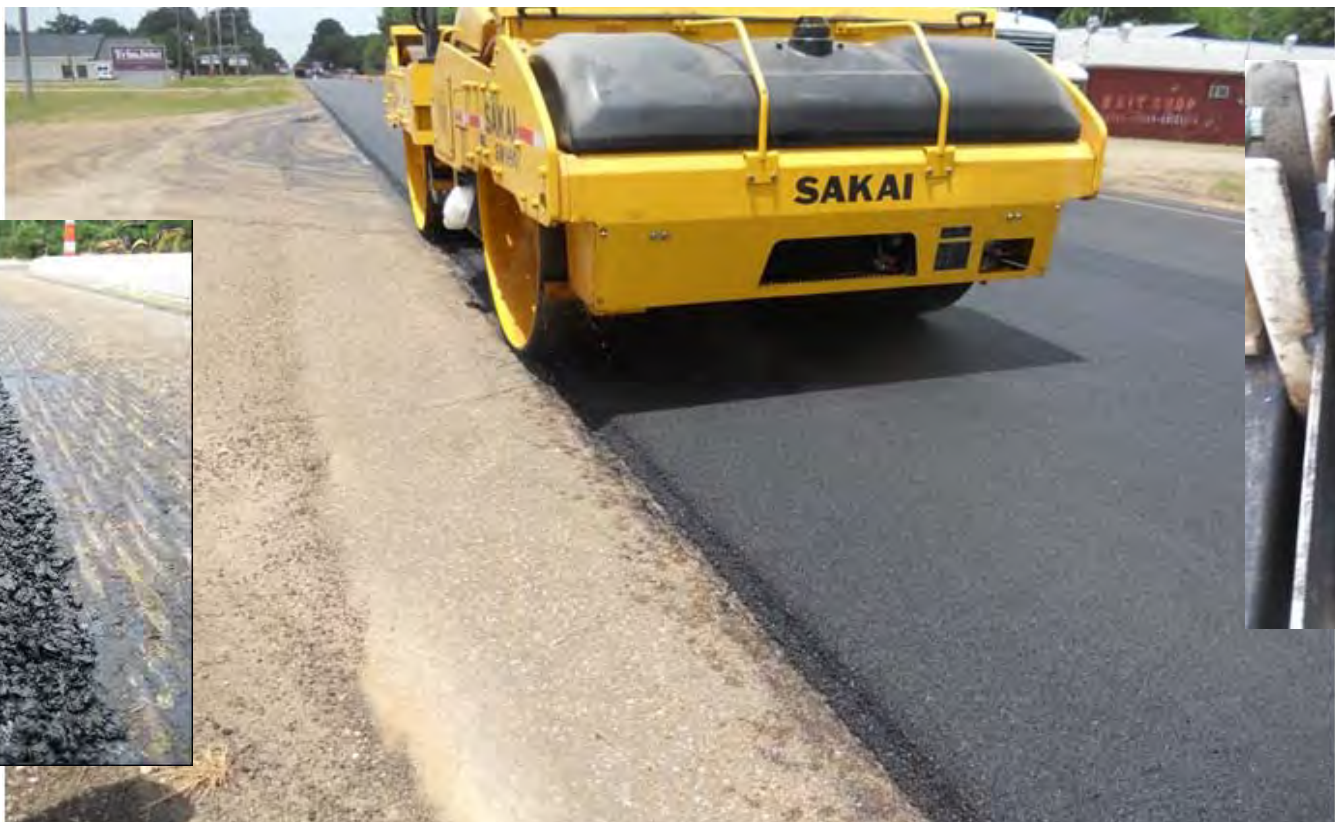
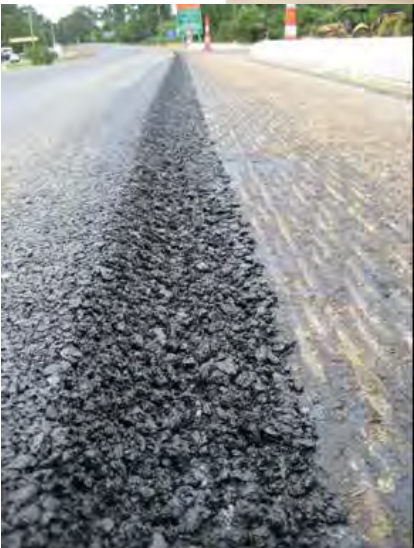
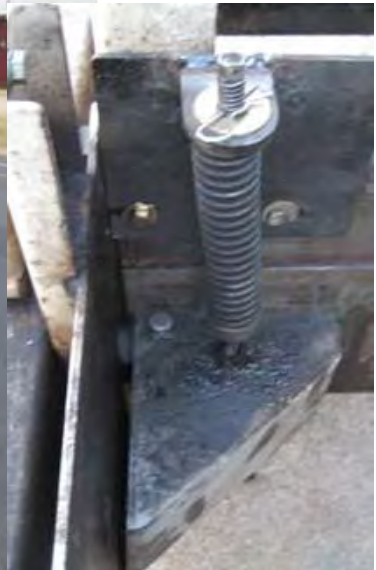
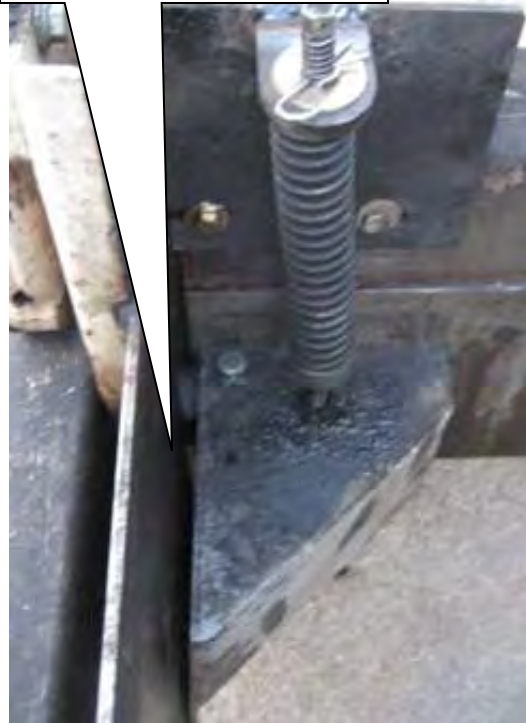
Mississippi State Road 182

Note the gap between the safety edge device and the end plate.

- The slope before and after rolling was about the same.
- Safety edge density was 1.8% higher than the control (no safety edge) section.
- Average slope was 37°.
- The shaft of the edge device was bent and created a gap between the end gate. The gap may have increased slope.
