# State of Nebraska

## Pavement Quality Indicator Test

Operator  
Sylvia Hilderbrand  
Project: F-385-3 (1009)

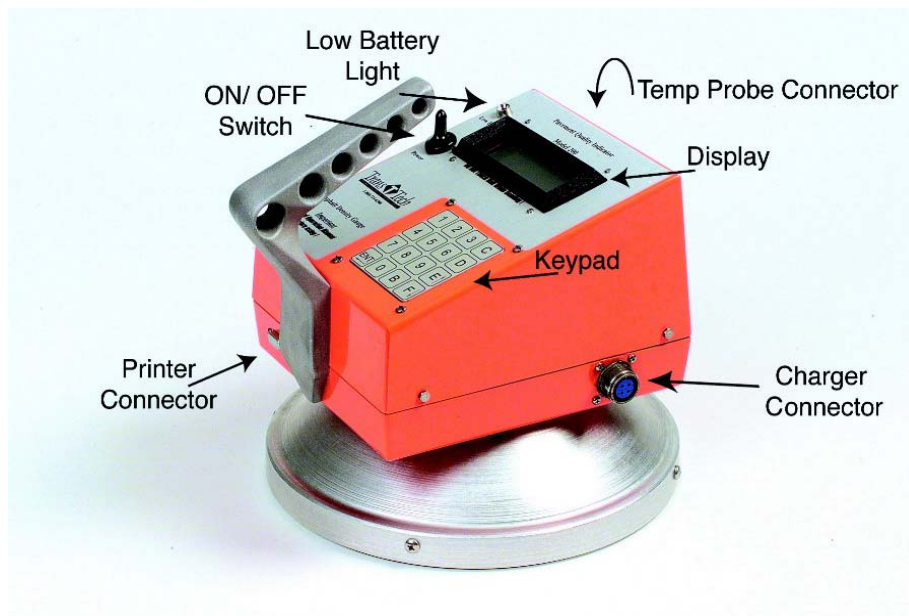
State of NE	PQI Test	Project : F-385-3 (1009)
Operator	Sylvia Hilderbrand
